UNITED STATES AIR FORCE
AIRCRAFT ACCIDENT INVESTIGATION
BOARD REPORT

C-17A, T/N 00-0173

**LOCATION: JOINT BASE ELMENDORF-RICHARDSON,
ALASKA**

DATE OF ACCIDENT: 28 JULY 2010

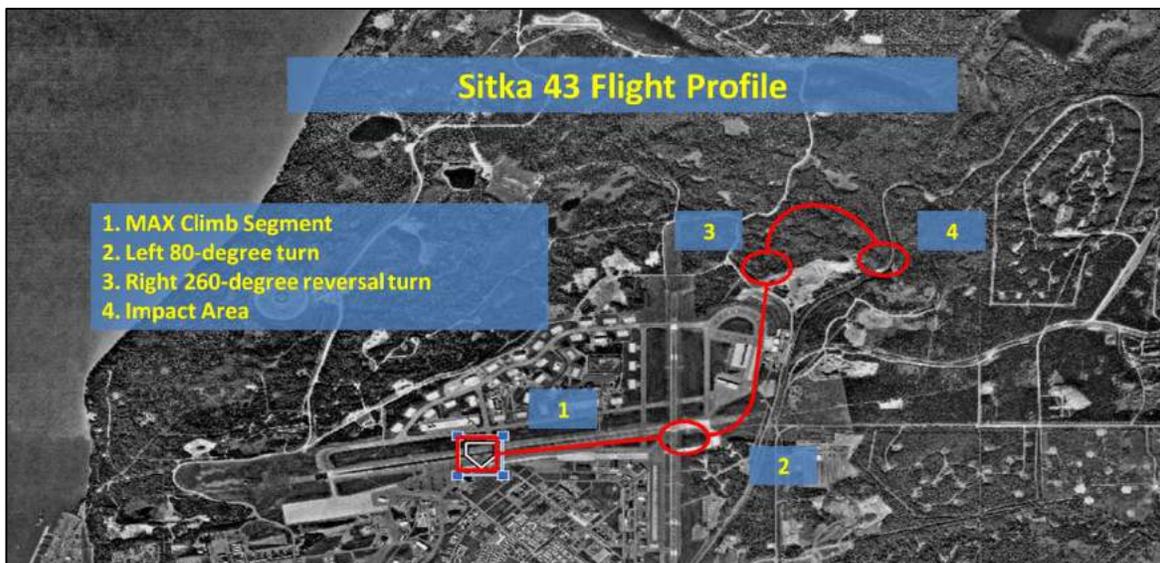
Approximately 62 seconds into the mishap sortie, the MA stalled. By this time, the deep stall protection system (the Angle of Attack Limiter System (ALS)) was active, but was overcome by the MP's rapid and aggressive maneuvers. (Tabs L-3, BB-3, CC-3 through CC-27) Within seconds, the MA's bank angle increased to a maximum of 82 degrees. The aircraft began to descend and ultimately reached a descent rate of 9,000 feet per minute, as airspeed decayed to 184 kts. (Tabs L-3, CC-3 through CC-27, CC-60 through CC-68, DD-21)

One-and-a-half seconds into the stall, several events occurred simultaneously: the MCP said "not so tight, brother"; the MSO said "watch your bank" three times; and the MP moved the control stick full left, applied left rudder, but maintained constant control stick pressure. (Tabs L-3, N-18, CC-3 through CC-27)

Five seconds prior to impact, the slats fully retracted. Approximately two seconds prior to impact, the MP was able to initiate a left roll of the aircraft, however, the roll rate was minimal due to the stall. (Tab L-3, CC-3 through CC-27) The stall protection system remained active until impact.
